## MEMORANDUM

<b>DATE:</b>	February 15 <sup>th</sup> , 2016
<b>FROM:</b>	Joe Harrington
<b>SUBJECT:</b>	February Weekly Progress Report @ Gold King
<b>TO:</b>	Steven Way

**Project:** Gold King Interim Water Treatment Plant (IWTP)  
**Location:** Gladstone, Colorado  
**Prepared for:** Emergency Response Unit – US EPA Region 8

**Reporting Period:** Feb 8 – Feb 15  
**Report No.:** 8

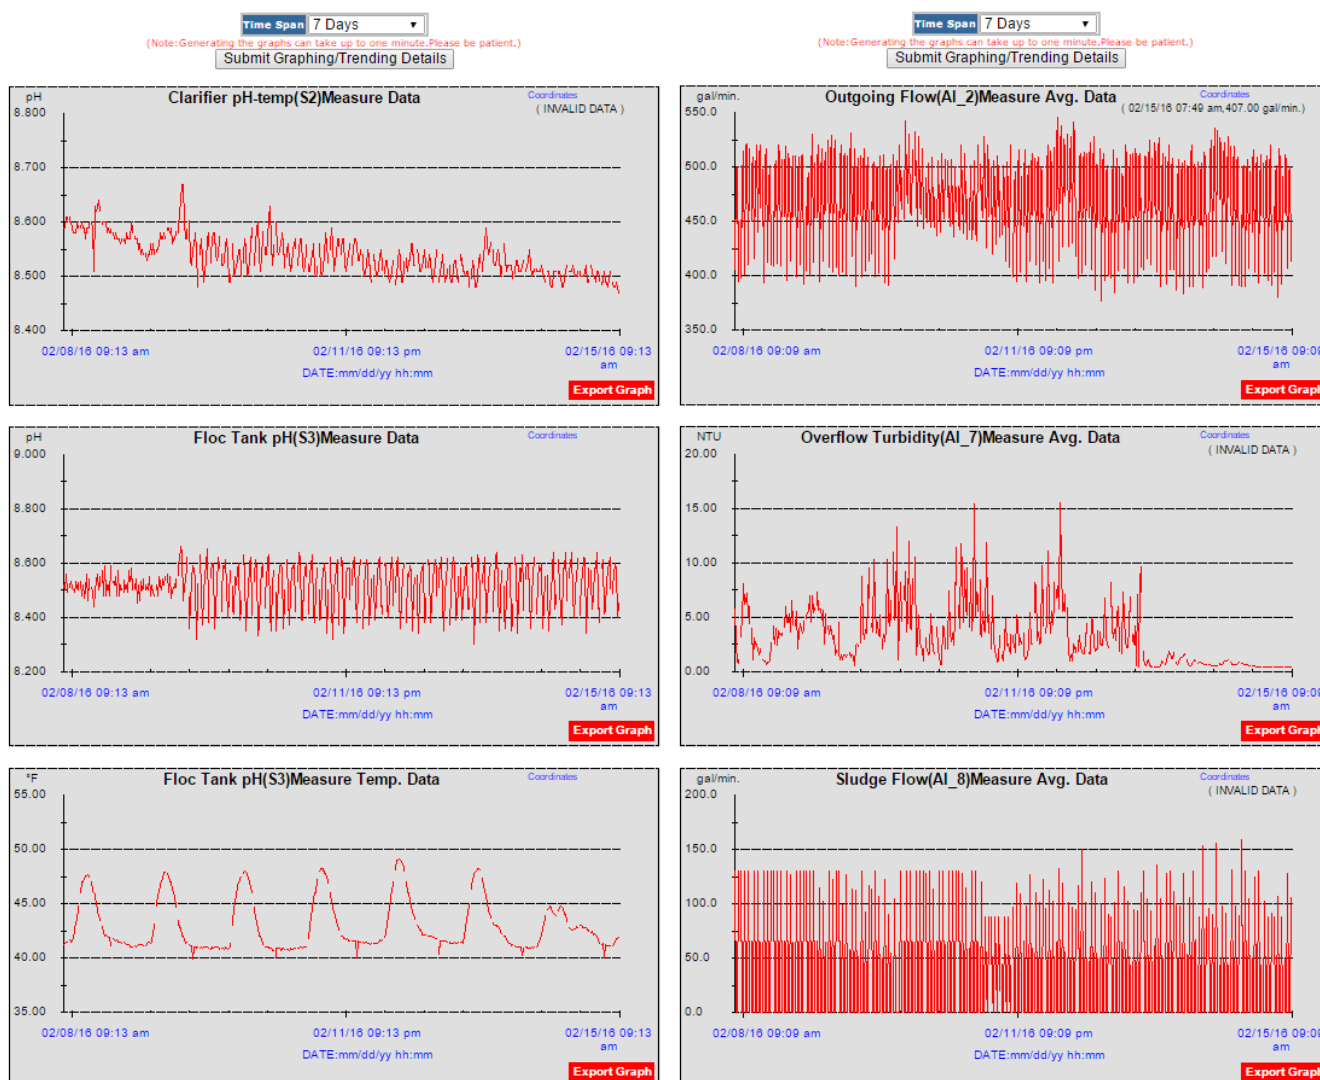
- The following graphs provide trending information collected by datalogging equipment during the previous 7 days. These dataloggers collect control information from the Lime Circuit (left) and Flow Circuit (right) Programmable Logic Controllers (PLCs) at the Gold King IWTP. Over the reporting period (2/8/16 – 2/15/16 inclusive) Alexco treated 4.77 million gallons at an average flow rate of 473 gpm with all discharged treated water leaving the 12" HDPE pipeline. pH and turbidity (the two key indicators of real-time quality) show no upsets to the plant operation during the past 7 days.

- Please note: Several days each week, the Alexco operators check the pH at both the floc tank and clarifier discharge. During this time, the probe is placed in vinegar (acid), and three pH buffers – 4, 7, and 10. While the probe is in the buffer, the datalogger may capture one of those points for tracking purposes, which explains the frequent periodic (daily) pH spikes seen on the graph.

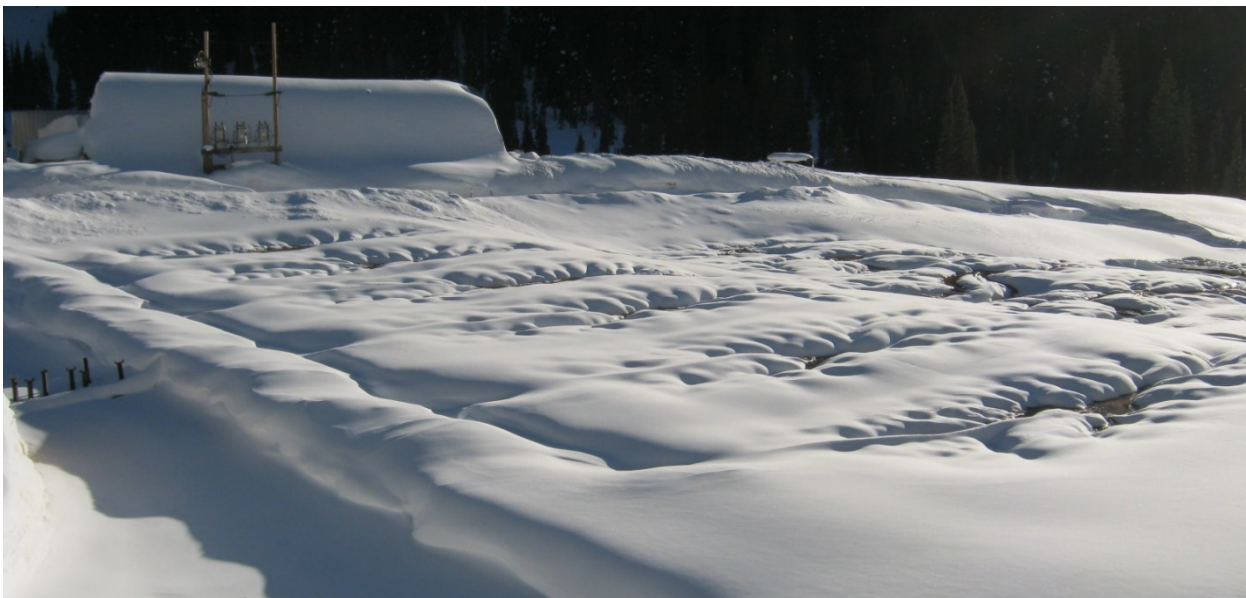
Figure 2: Sludge Bags – Taken on 2/9/2016

- **Additional Bags** – Alexco has purchased additional textile bags (2X 125' x 45 and 1X 90' x 45') that are currently located at site and can contain up to 2,000 CY of sludge. Alexco is planning to install one or two of these additional textile bags if needed prior to or during spring melt depending on access and snow cover. These new bags should demonstrate improved performance because of the improved quality of floc mixture and consistent dosing rate.

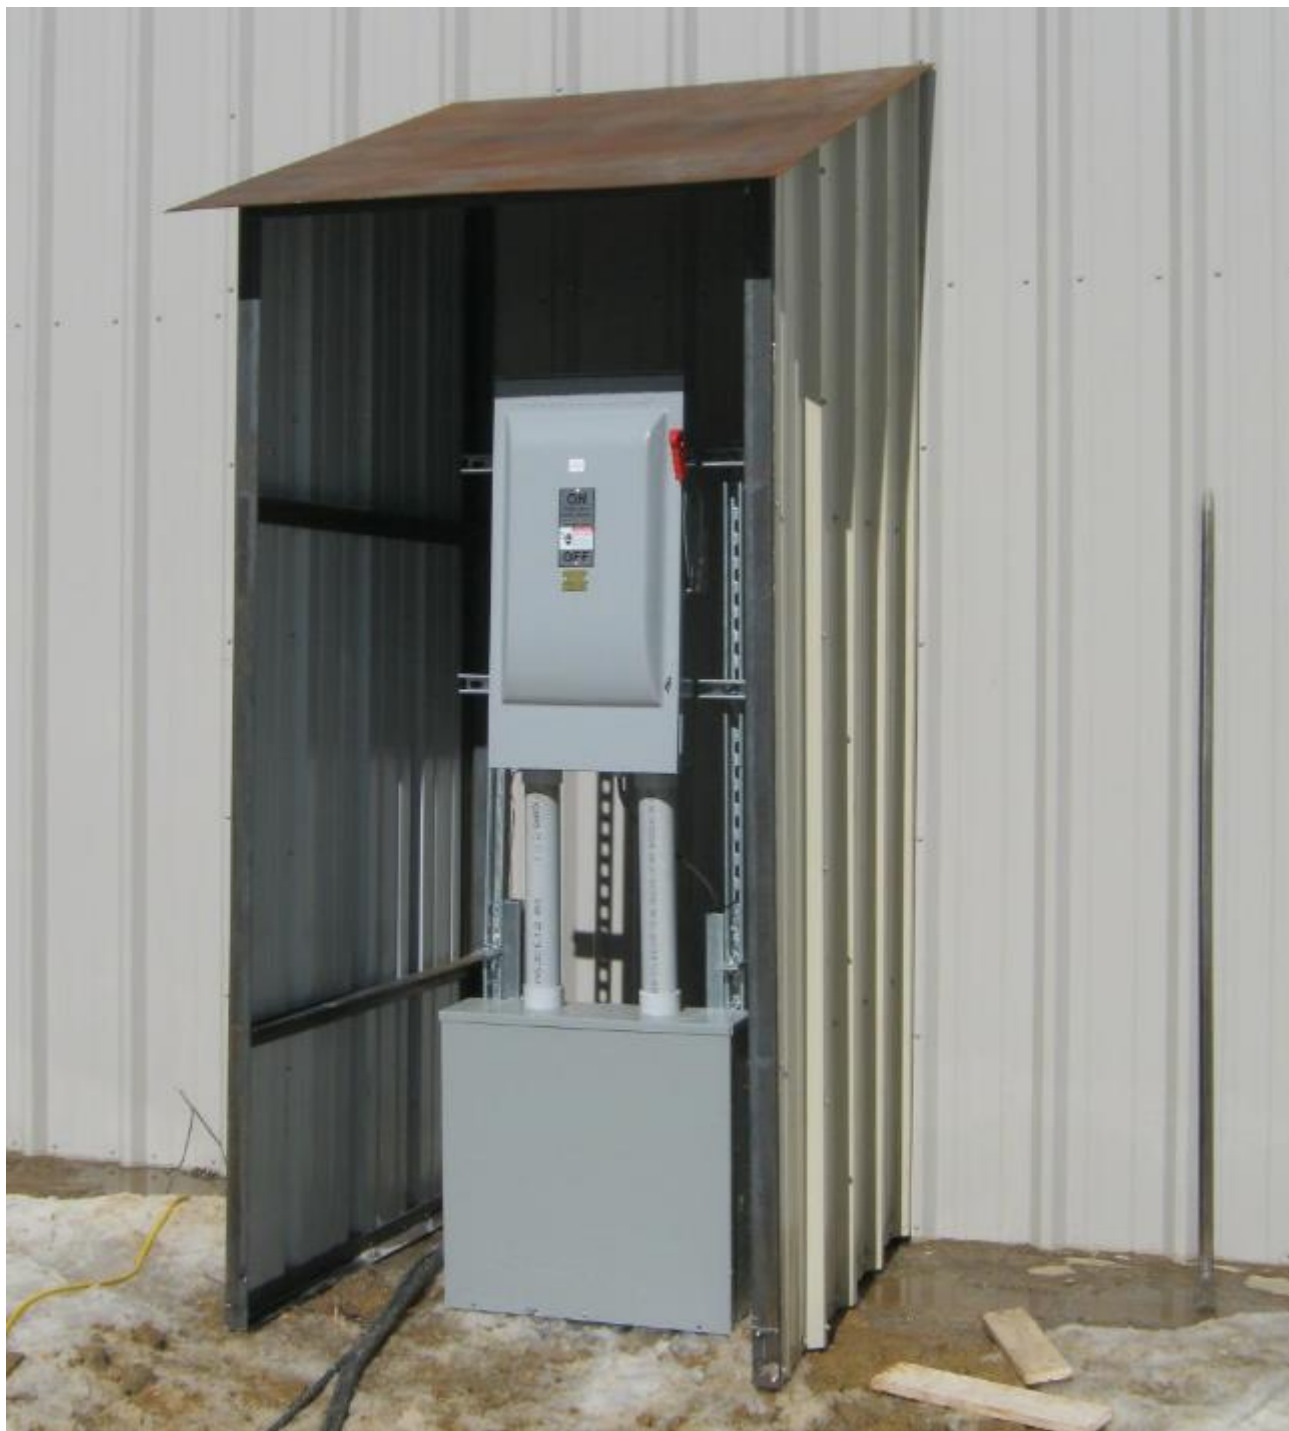
Figure 3: Summit Mechanical installed a steel structure to protect the main disconnect –  
Taken on 2/9/2016

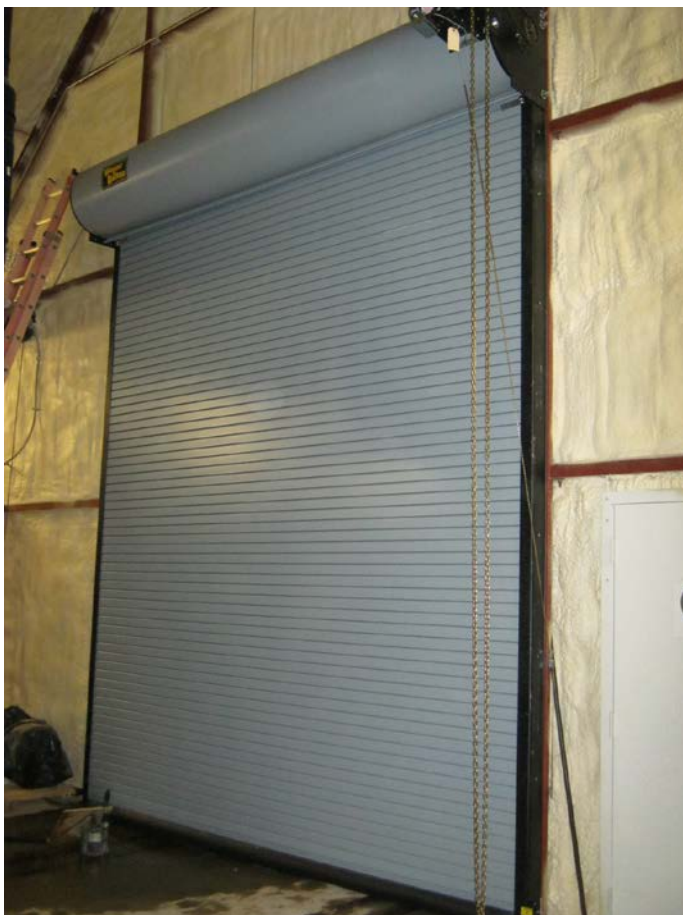
- **Door Replacement** - Summit Mechanical replaced the 12' x 14' roll-up door on February 11. The existing door was weighed down by ice/snow, which damaged the chain drive. The new door is of better quality, insulated, and better suited for the extreme conditions at site.

Figure 4: Summit Mechanical installed a new 12' x 14' insulated door – Taken on 2/9/2016

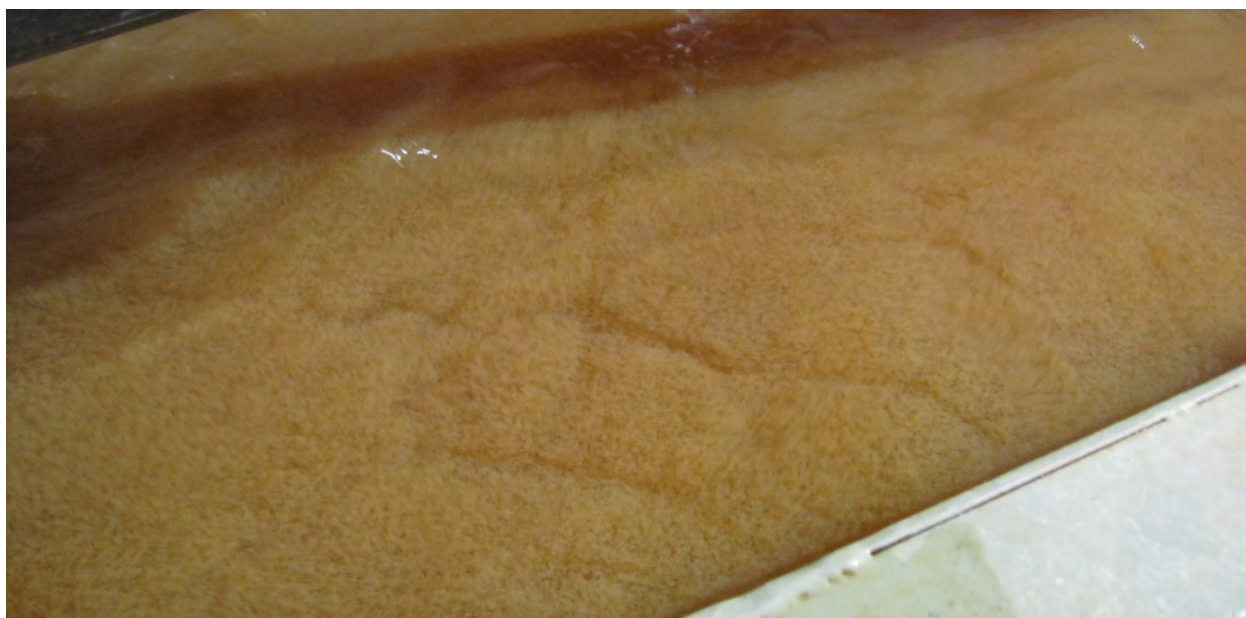
Figure 5: Floc tank continues to make large floc that settles well in the clarifier. NTUs are averaging between .5 and 5 over the last few weeks. – Taken on 2/9/2016
